Econorm manhole system tested for engineering company Prinzing GmbH

A new manhole-cover design in rapid corrosion test

By Prof. S. Schwantes,
Labor für Werkstofftechnik, Fachhochschule
für Technik Ulm, Germany

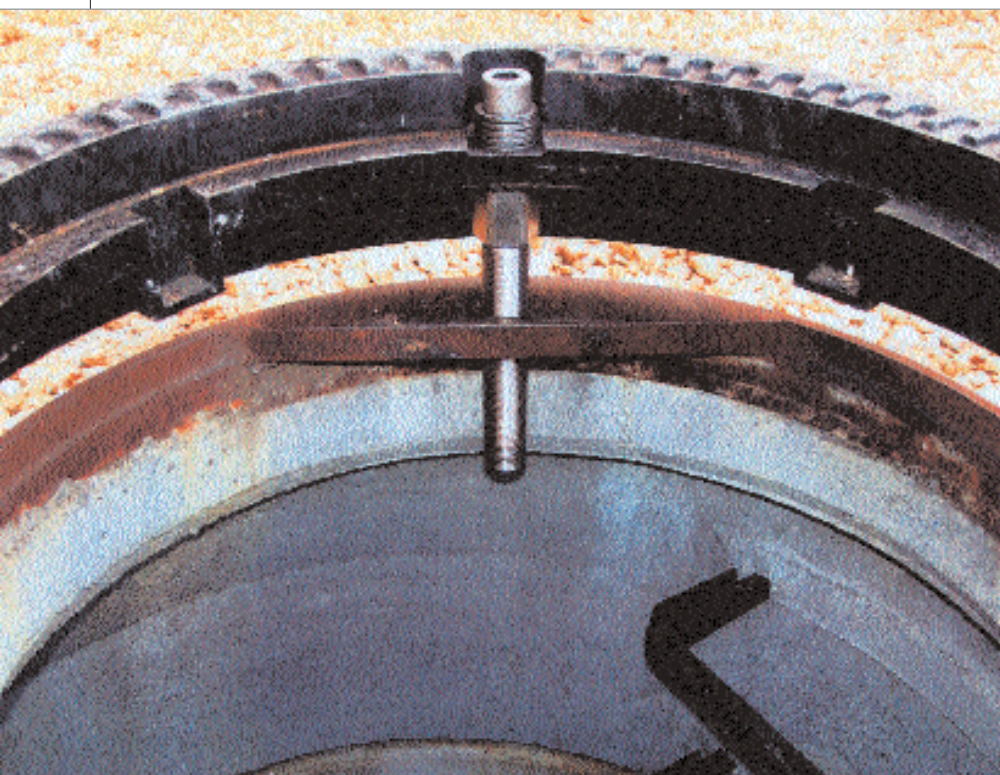
Concrete collar, bearer ring, frame and spindles in actual use

Prinzing GmbH, Blaubeuren in Germany is now offering the econorm* manhole cover, a new design for drainage systems. A special feature of this product is that the height between the frame and bearer ring can be adjusted. This is made possible by three stainless steel spindles, mounting bolts and disc springs. During a four-week rapid test, the laboratory for materials technology at the University of Technology, Ulm in Germany looked into whether the adjustment spindles and mounting bolts would corrode, whether the corrosion of the remaining components would be accelerated by possible potential differences between them and the stainless steel and whether the bolt threads and spindles would still turn easily in a corrosive environment.

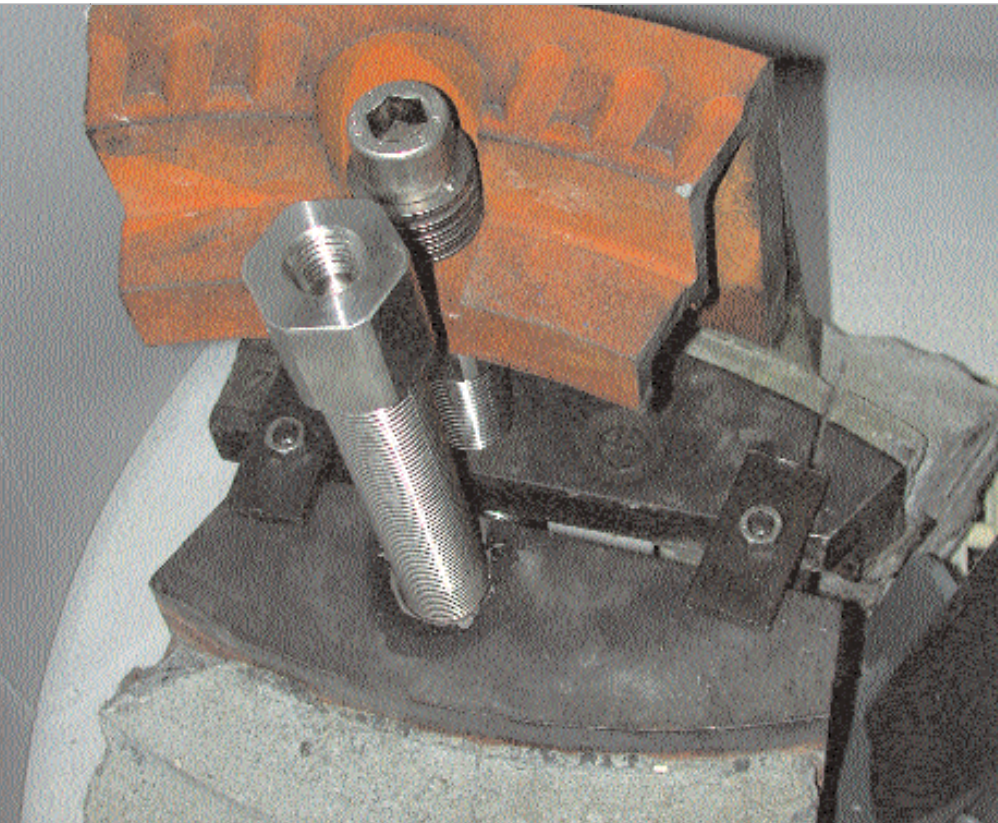
Test component before exposure to corrosion

Two bearer ring segments embedded in concrete, each with a spindle hole, were bolted together and a bearer segment was also bolted to part of the frame for the test. A part of the cover was used to produce the distance to the bearer ring. A freely rotating spindle was mounted in the other bearer ring segment and then the whole test assembly was placed in the test chamber to simulate the real installation situation.

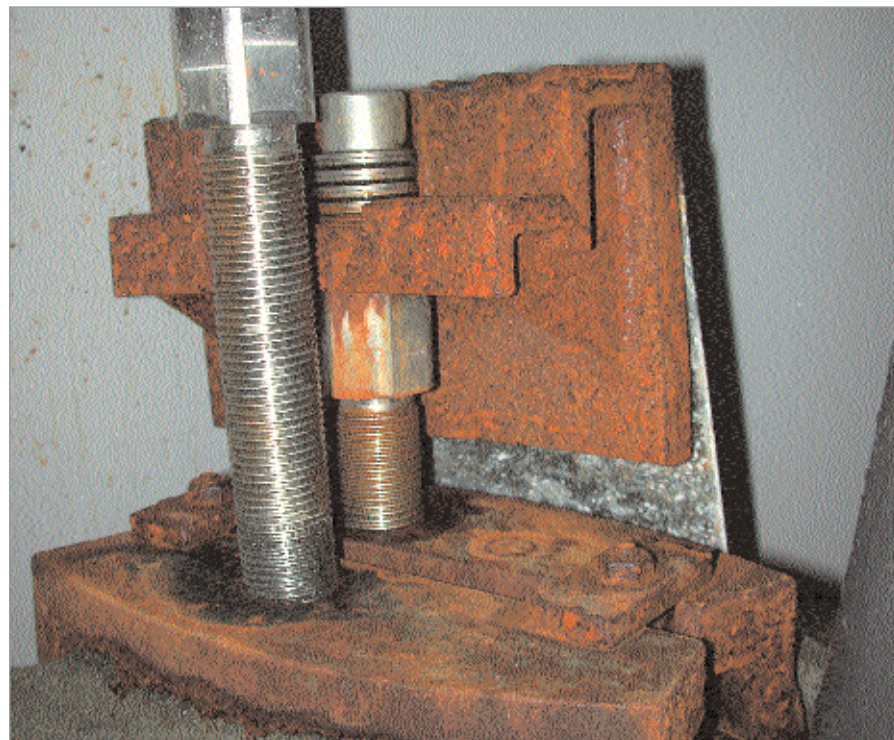
Rapid test after 16 days

Documenting the progress with pictures every three to four days is an easy way to spot rapid surface corrosion attack on grey iron and steel components. Although the surface of stainless steel components become discoloured, this is due to rust particles from the surroundings. The coating is loose, can be wiped off and does not lead to corrosion damage, nor does it impair the operation of the spindles, springs and bolts.

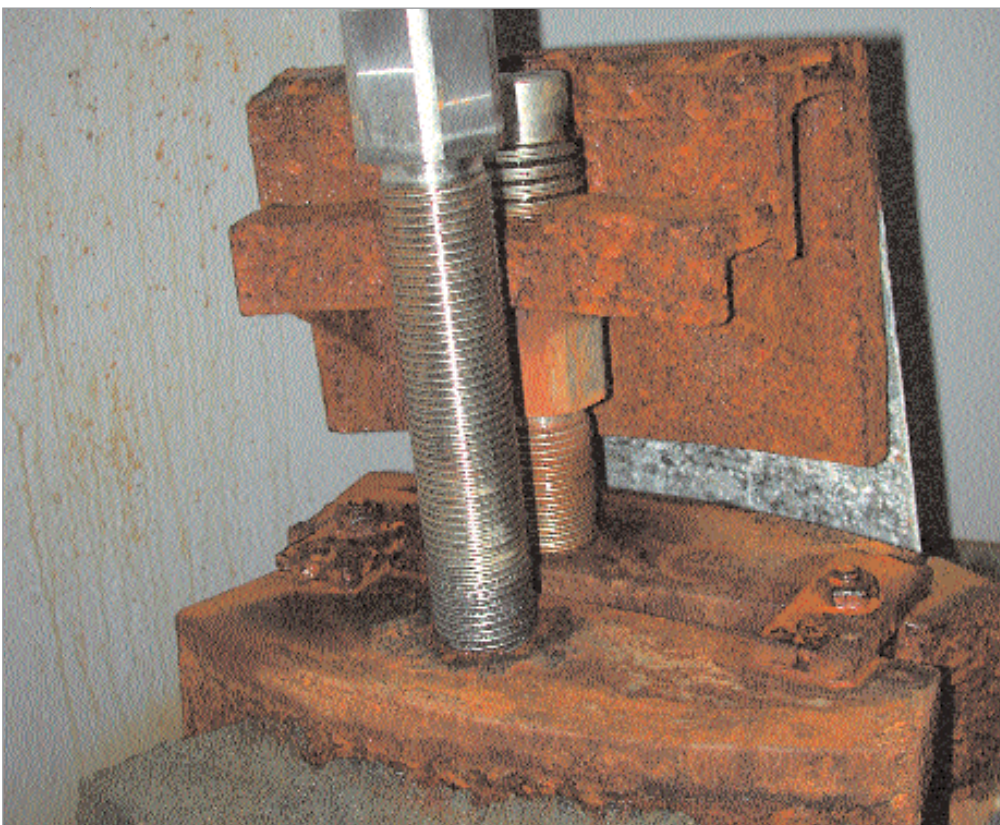
At the end of the test after 29 days

After the test period was over, considerable corrosion could be seen on the grey iron components. There was a layer of white salt consisting of zinc dissolution (white rust) over the cover but the zinc had not completely corroded away at any place. The bolts, disc springs and spindles made from stainless steel showed no traces of corrosion. The only lubricated spindle to be fitted could still be turned easily but the bolt which was not lubricated could not be loosened or turned using the appropriate tool.

The surface of the bearer ring which was treated with permanent lubricant showed only slight corrosion since the grease had largely prevented the aggressive electrolyte from wetting the surface. The lubricant was still fully effective and the spindle could still be turned easily by hand.

In the area of the bolts, disc springs and spindle on the side which was not lubricated, corrosion of the casting in contact with the stainless steel was no worse than in the other places. Comparisons with manhole covers exposed to the weather in the open and manhole covers in use at

Prinzing showed significantly less surface wear even after many years exposure. It can therefore be concluded that the corrosion test had a very pronounced acceleration effect for the grey iron.
